Mains Interference Plagues Solar Parks Too

GOSSEN METRAWATT's monitoring system doesn't miss a single fault.

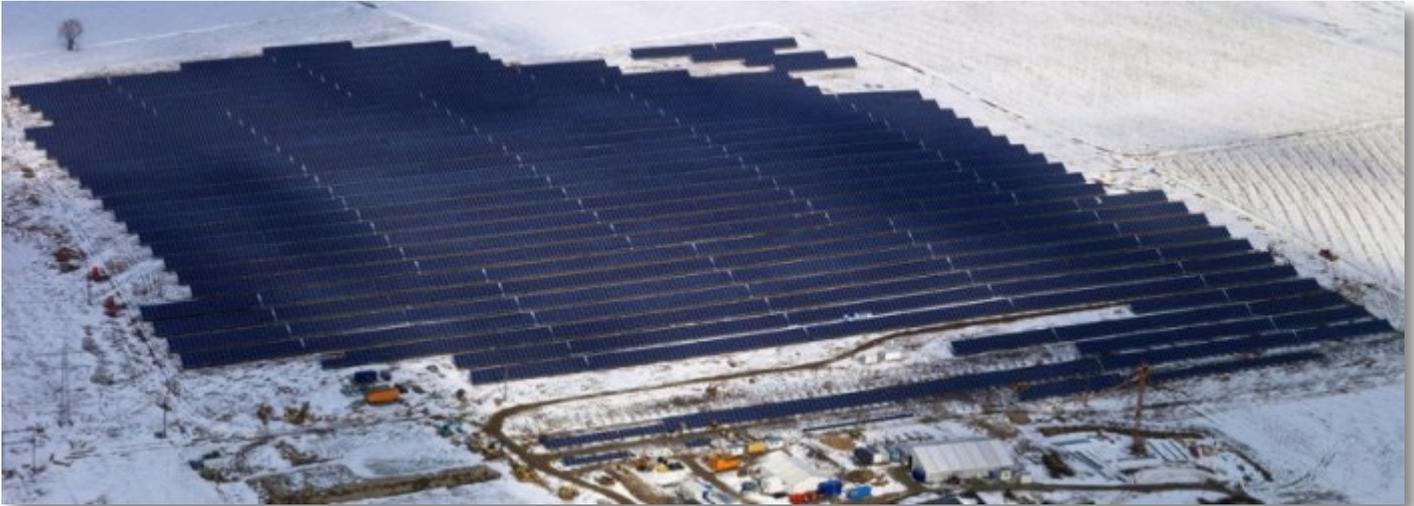
Figure 1: Tauberland Solar Park – Aerial View

The Tauberland Solar Park in Wertheim, Germany, went online in 2010. Equipment completed during the East and West construction phases generates a total of roughly 22 MWp (peak) and is currently supplying the equivalent of 9000 households with electrical power. With a planned power rating of 72 MWp after the final construction phase, the solar park is not only one of Europe's largest photovoltaic systems, it's also one of the most modern and effective of its type (see figure 1).

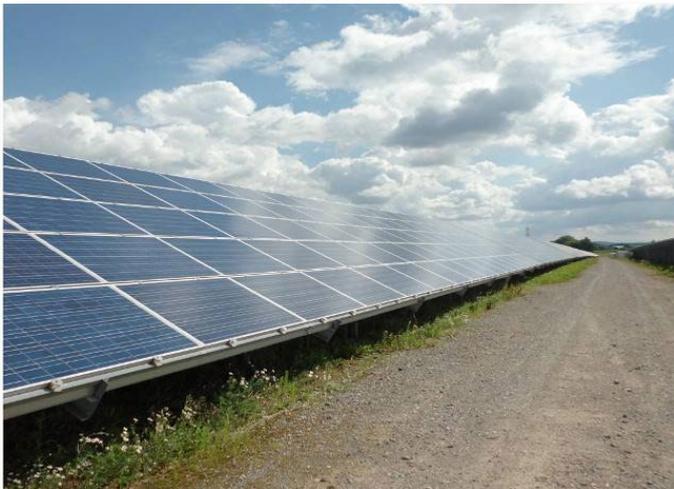
Figure 2: Tauberland Solar Park – Photovoltaic Panels

Converting sunlight into electrical energy at Tauberland should result in reduced CO2 emissions amounting to 5600 tons per year. This quantity corresponds to the annual emissions generated by a medium sized, coal-fired power plant. The system covers an area of 850,000 square meters (more than 9 million square feet), and includes roughly 180,000 modules from various manufacturers (see figure 2).

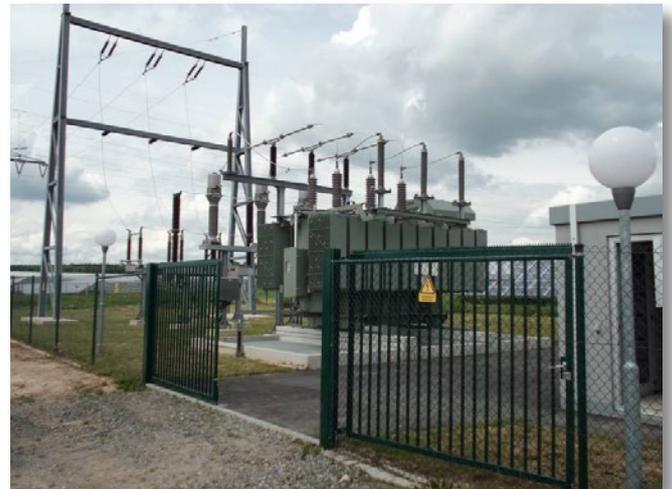
Figure 3: Tauberland Solar Park – 110/20-kV Transformer

A 110/20 kilovolt transformer feeds power to the high-voltage grid which belongs to operating company EnBW. The transformer has a rating of 40 MVA and replaced a provisional solution in 2010. Current planning specifies that a total of two transformers will be used to feed power to the grid after completion of the final construction phase (figure 3).

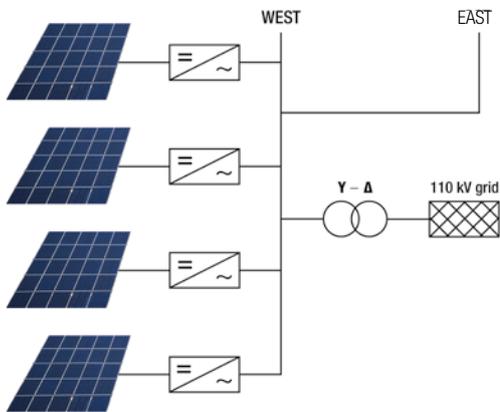
Figure 4: Tauberland Solar Park Schematic Plant Diagram

Project costs amounted to roughly € 100 million and have been financed by government organizations as well as private investors. Feeding power to the grid from the West construction phase is handled by four inverters with a total power rating of 8 MW. (Figure 4).

The inverters are equipped with relays for voltage monitoring. If the limit value of $\pm 10\%$ is violated, the relay is tripped and disconnects the inverters from the grid.

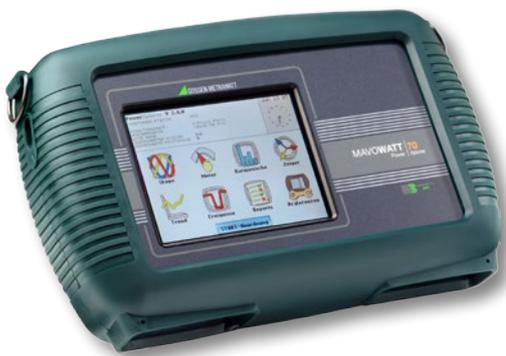
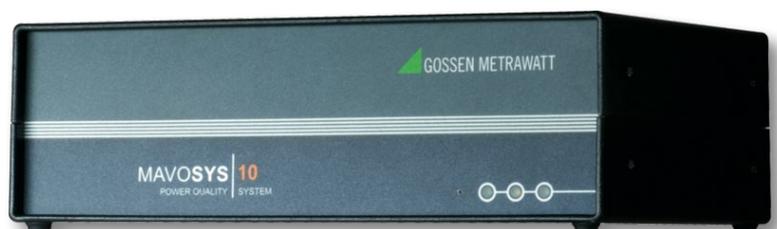
Two independent authorities were commissioned to perform measurements in order to pinpoint the causes of the shutdowns. Amongst other instruments, the HBS-Box, a portable power disturbance analyzer manufactured by HBS Steuerungstechnik, together with primary components including GOSSEN METRAWATT's MAVOSYS 10 and MAVOWATT 70 power disturbance analyzers (see figure 5a, b) were used for analysis purposes.

Figure 5a: Power Disturbance Analyzer Mavowatt 70

Figure 5b: Power Disturbance Analyzer Mavosys 10

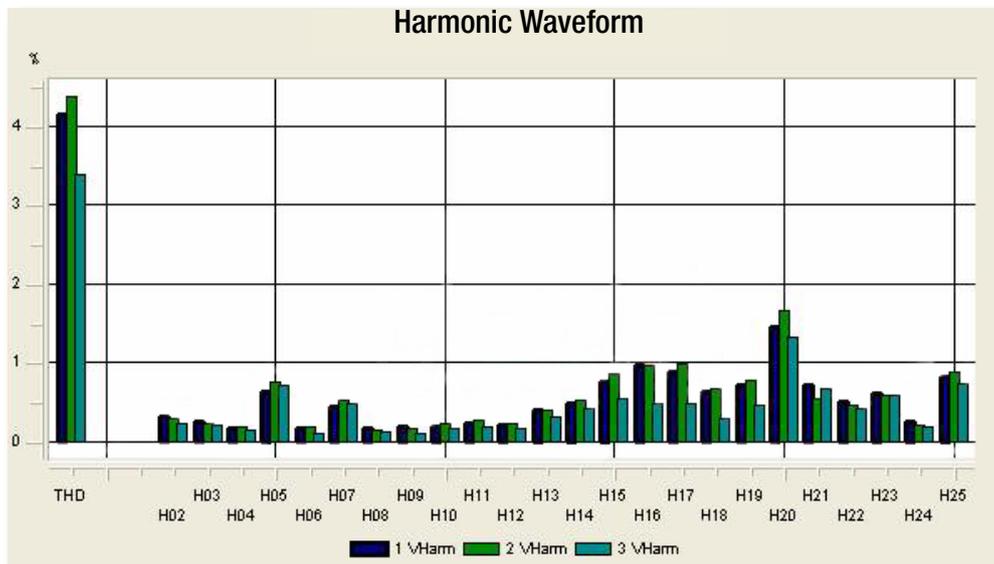
After conducting a series of measurements at the medium and low-voltage levels, the experts discovered the cause: the inverters were influencing each other reciprocally. Inverter operation was causing mains pollution. Above all the 15th and 25th harmonics were very pronounced.

Total harmonic distortion was 4.4%, which is considered a fairly high value nowadays (figure 6). With the help of the above mentioned power disturbance analyzers, it was determined that a resonant circuit occurred for which impedance reached its maximum at roughly 1000 Hz (resonant frequency) due to transformer inductance and cable capacitance. As a result of feeding harmonic current to the grid, there was a very high level of 20th harmonics.

Figure 6: Overall VTHD as Percentage (recorded with HBS-Box and Mavosys 10)

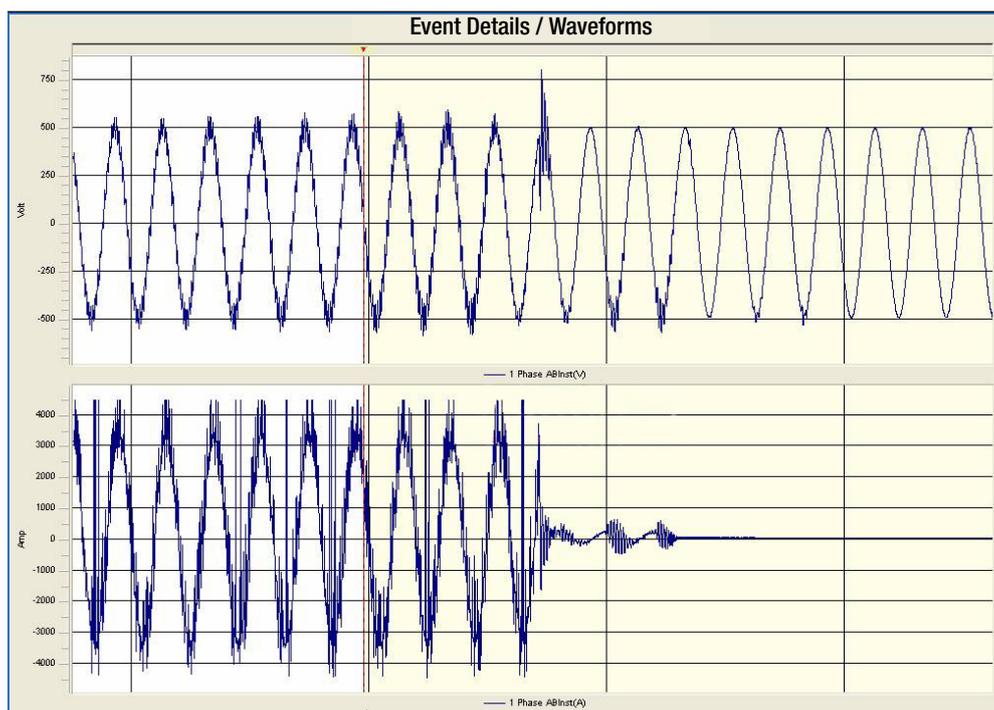
As a result of high current values and high line impedance, the TRMS voltage value for the entire system exceeded the limit threshold, the protective device was tripped and the inverters were disconnected from the grid. After the voltage level had dropped back down to the specified level, the inverters were connected to the grid once again. Depending on weather conditions, the inverters were disconnected from the grid several times a day (see figure 7).

Figure 7: Characteristic Voltage and Current Curves Before and After Shutting Down the Inverters

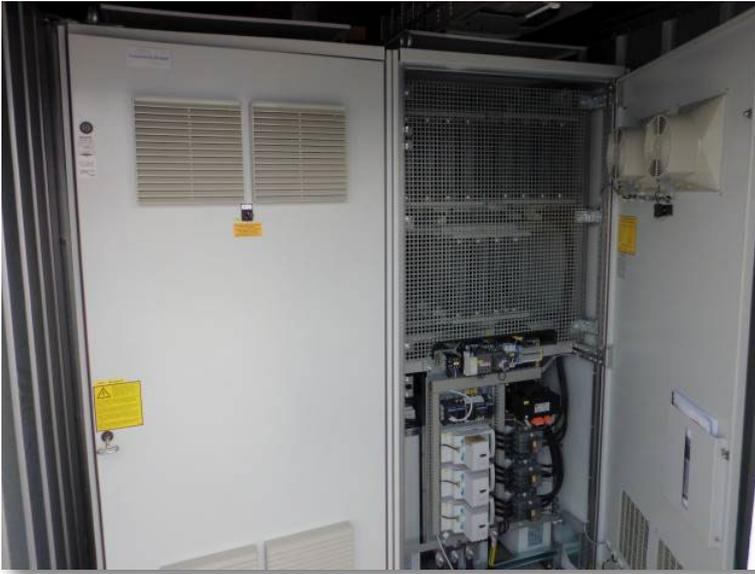
Figure 8: Passive Harmonic Filter from Condensator Dornit

After the cause of the failures had been determined, Condensator Dornit from Brilon installed a passive harmonic filter with total compensation power of 174 kVAr. The filter is comprised of several damped capacitors with neutral point connection (see figure 8).

These frequency-sensitive resistors in the electrical resonant circuit generate a narrow-band “absorption effect” for the currents of the undesired frequencies and quench them. At the same time, the impedance maximum is attenuated. As a result, harmonic currents fed to the grid are reduced to a minimum and harmonic voltages are kept within “normal” values.

Immediately after placing the filter into operation, voltage quality improved and the TRMS voltage value has remained within the tolerance range since the filter was installed. As predicted, the inverters with filter circuit remain uninterruptedly in operation and fulfill their purpose, namely feeding electrical power generated from solar energy to the grid whenever it’s available.
